Manhole Inspection Summary

Manhole # S21QQ_001MH

Inspection ☐ Is Incomplete Rating: **4) Poor**

Location Address: **3310 AUCHENTOROLY-WOODBROOK** Cross Street: **BRYANT AVE**

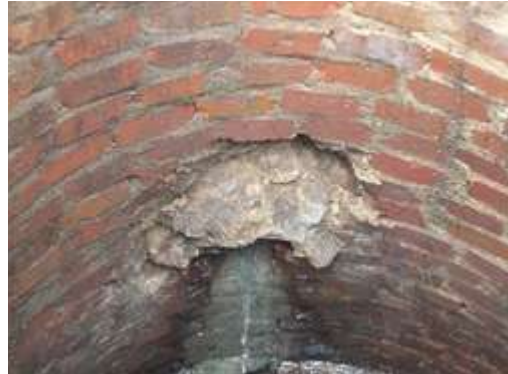
Defect 3

Condition: ☐ Sound ☐ Cracked ☐ Root Intrusion ☐ Loose Brick ☒ **Deteriorated**

DETERIORATED CORBEL

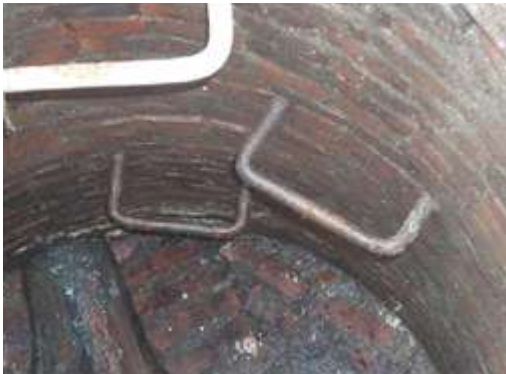
Defect 2

Condition: ☐ Sound ☐ Cracked ☐ Root Intrusion ☐ Loose Brick ☒ **Deteriorated**

DETERIORATION OF BARREL

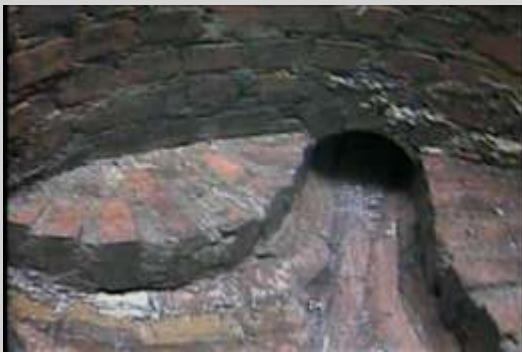
12 O'Clock Outflow

DETERIORATION OF BARREL

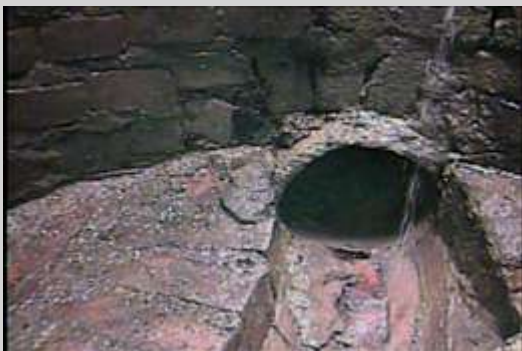
4 O'Clock Inflow

DETERIORATION OF BARREL

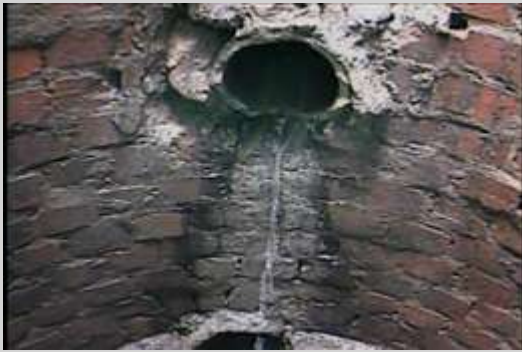
4 O'Clock Inflow

DETERIORATION OF BARREL

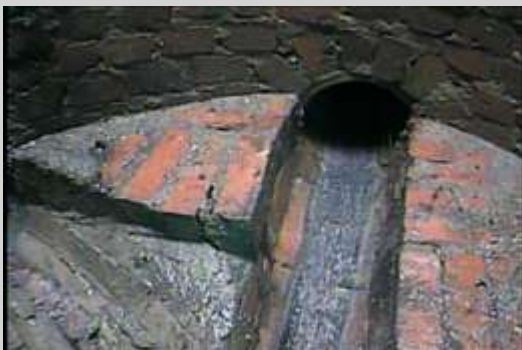
6 O'Clock Inflow

DETERIORATION OF BARREL

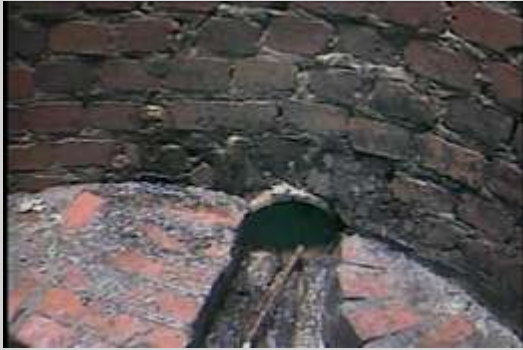
9 O'Clock Inflow

DETERIORATION OF BARREL
